LArPix v1 testing

DUNE Pixel Readout Weekly Meeting

2019/5/9

Testing of chip packaging with v1 ASIC

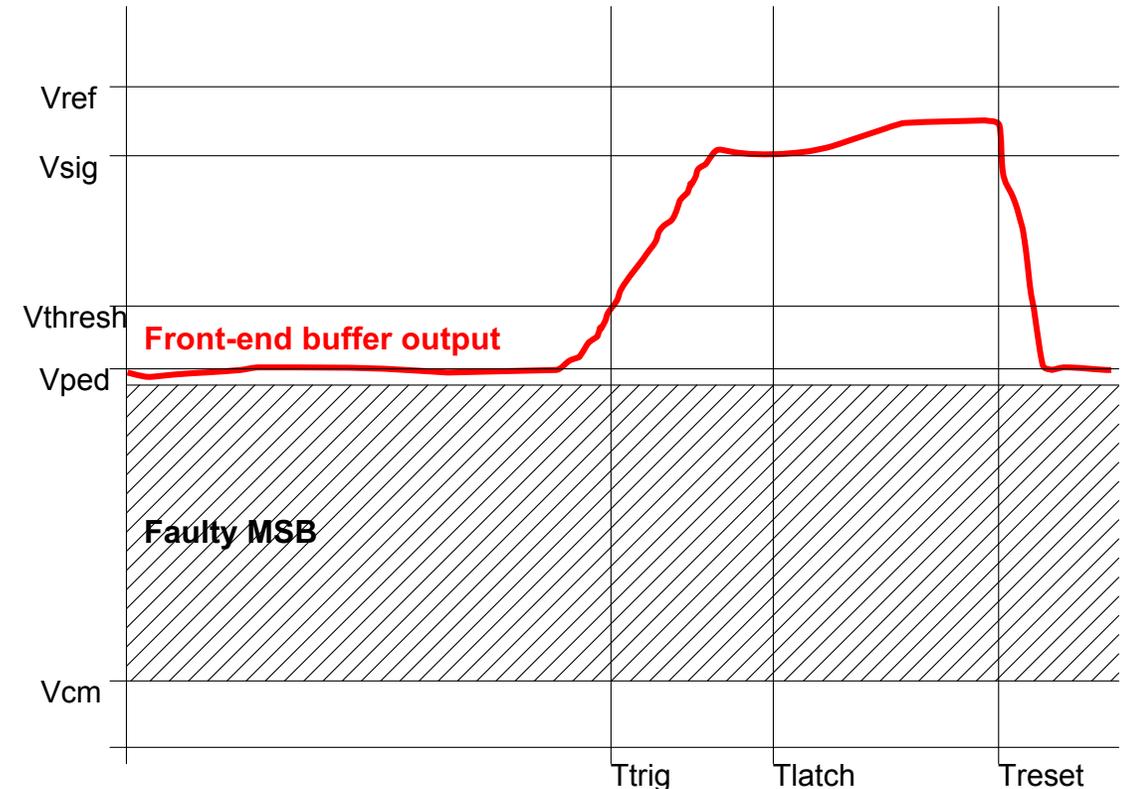
Front end timing diagram

Issue: Race condition in SAR ADC implementation

v2 fix: Already fixed in design, confirmed with full timing simulations
